**PROGRAM 624A
QUARTERLY RELIABILITY AND
QUALITY ASSURANCE REPORT
VOLUME I: RELIABILITY**

JULY 1966

**MARTIN COMPANY
A DIVISION OF MARTIN MARIETTA CORPORATION
Denver, Colorado**

SSD-CR-66-168 (VOL I)

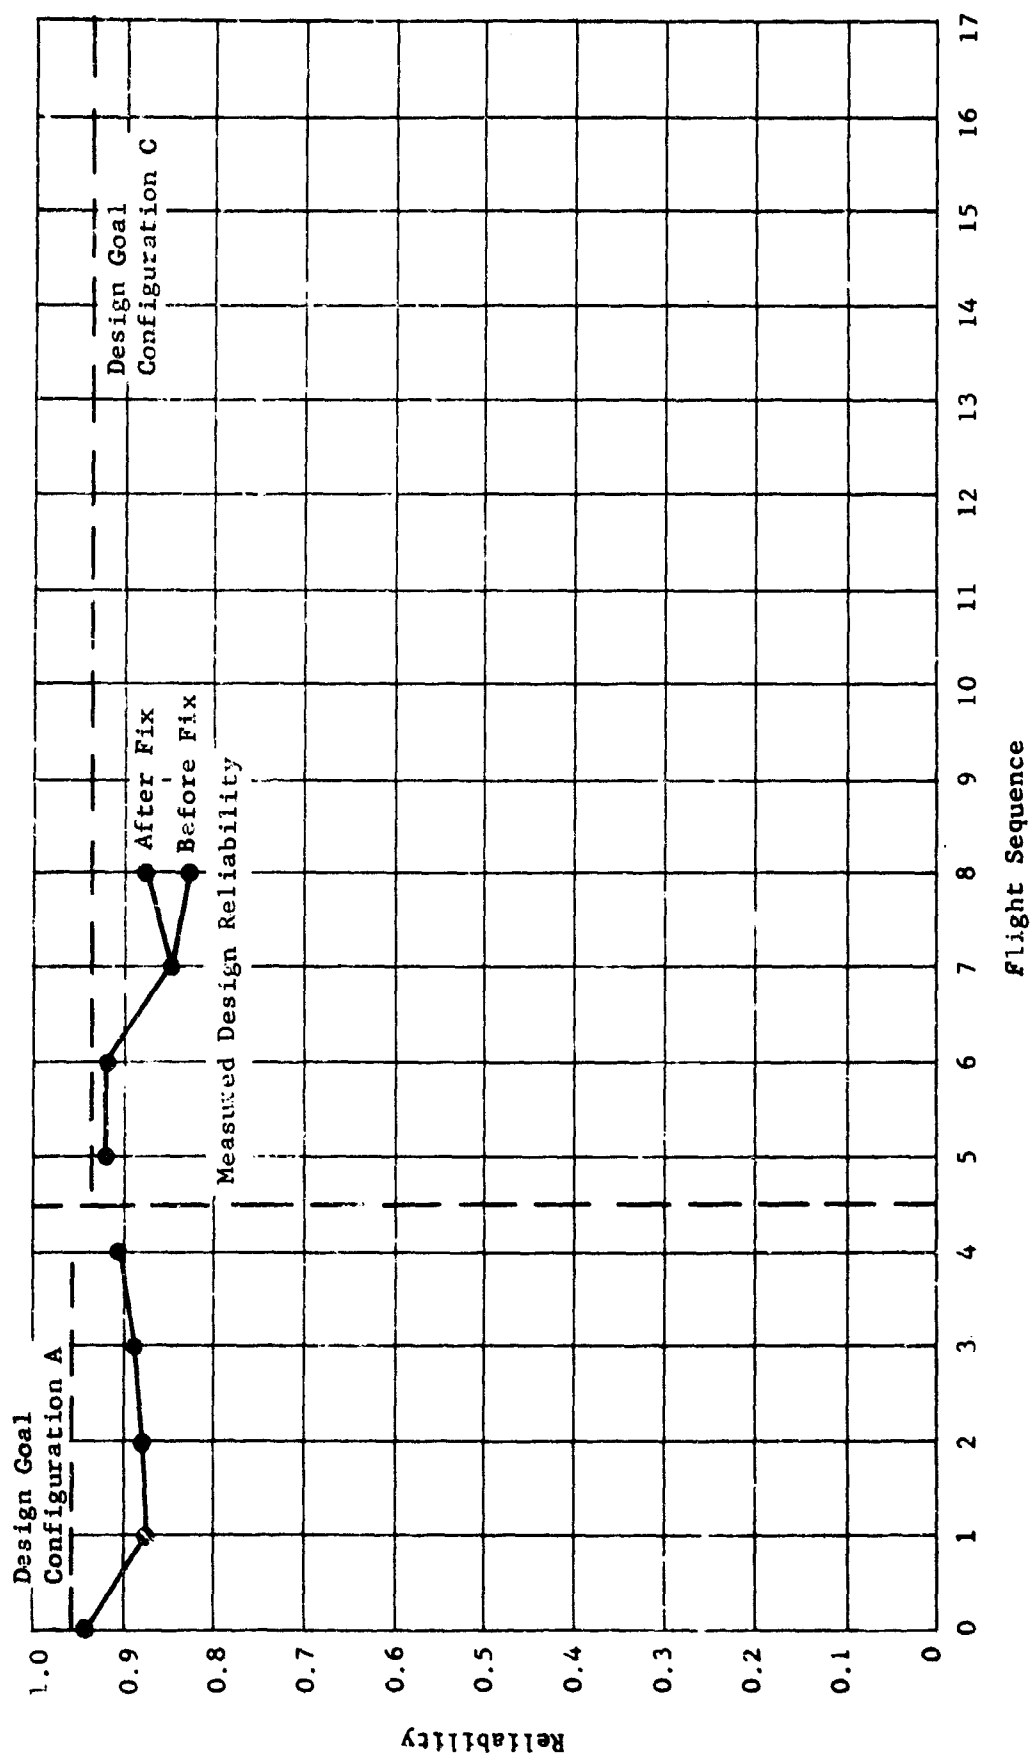
Fig. 1 Design Reliability Measurement (Performance Criteria) for Martin Portion of Titan III (Configurations A and C) during Flight.

- 1) Design Reliability Measurement (Performance Criteria) for Martin Portion of Titan III (Configurations A and C) during Flight, Fig. 1;
- 2) Achieved Reliability Measurement (Performance Criteria) for Martin Portion of Titan III (Configurations A and C) during Flight, Fig. 2.

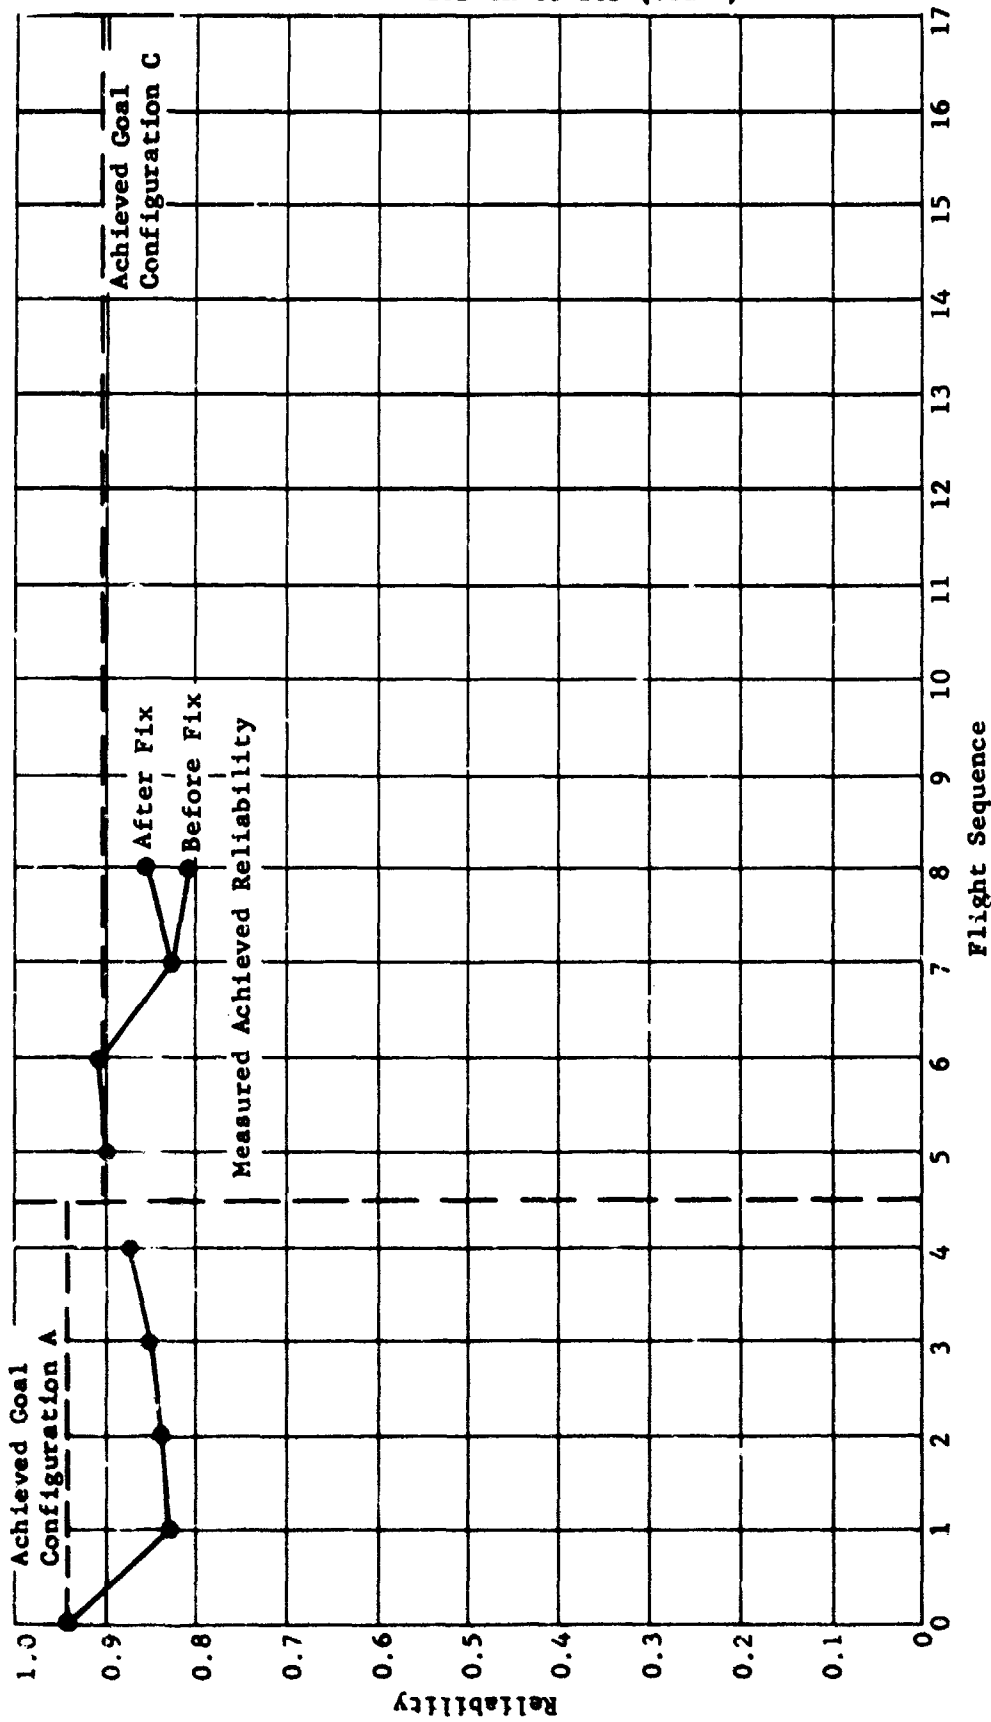
Fig. 2 Achieved Reliability Measurement (Performance Criteria) for Martin Portion of Titan III (Configurations A and C) during Flight

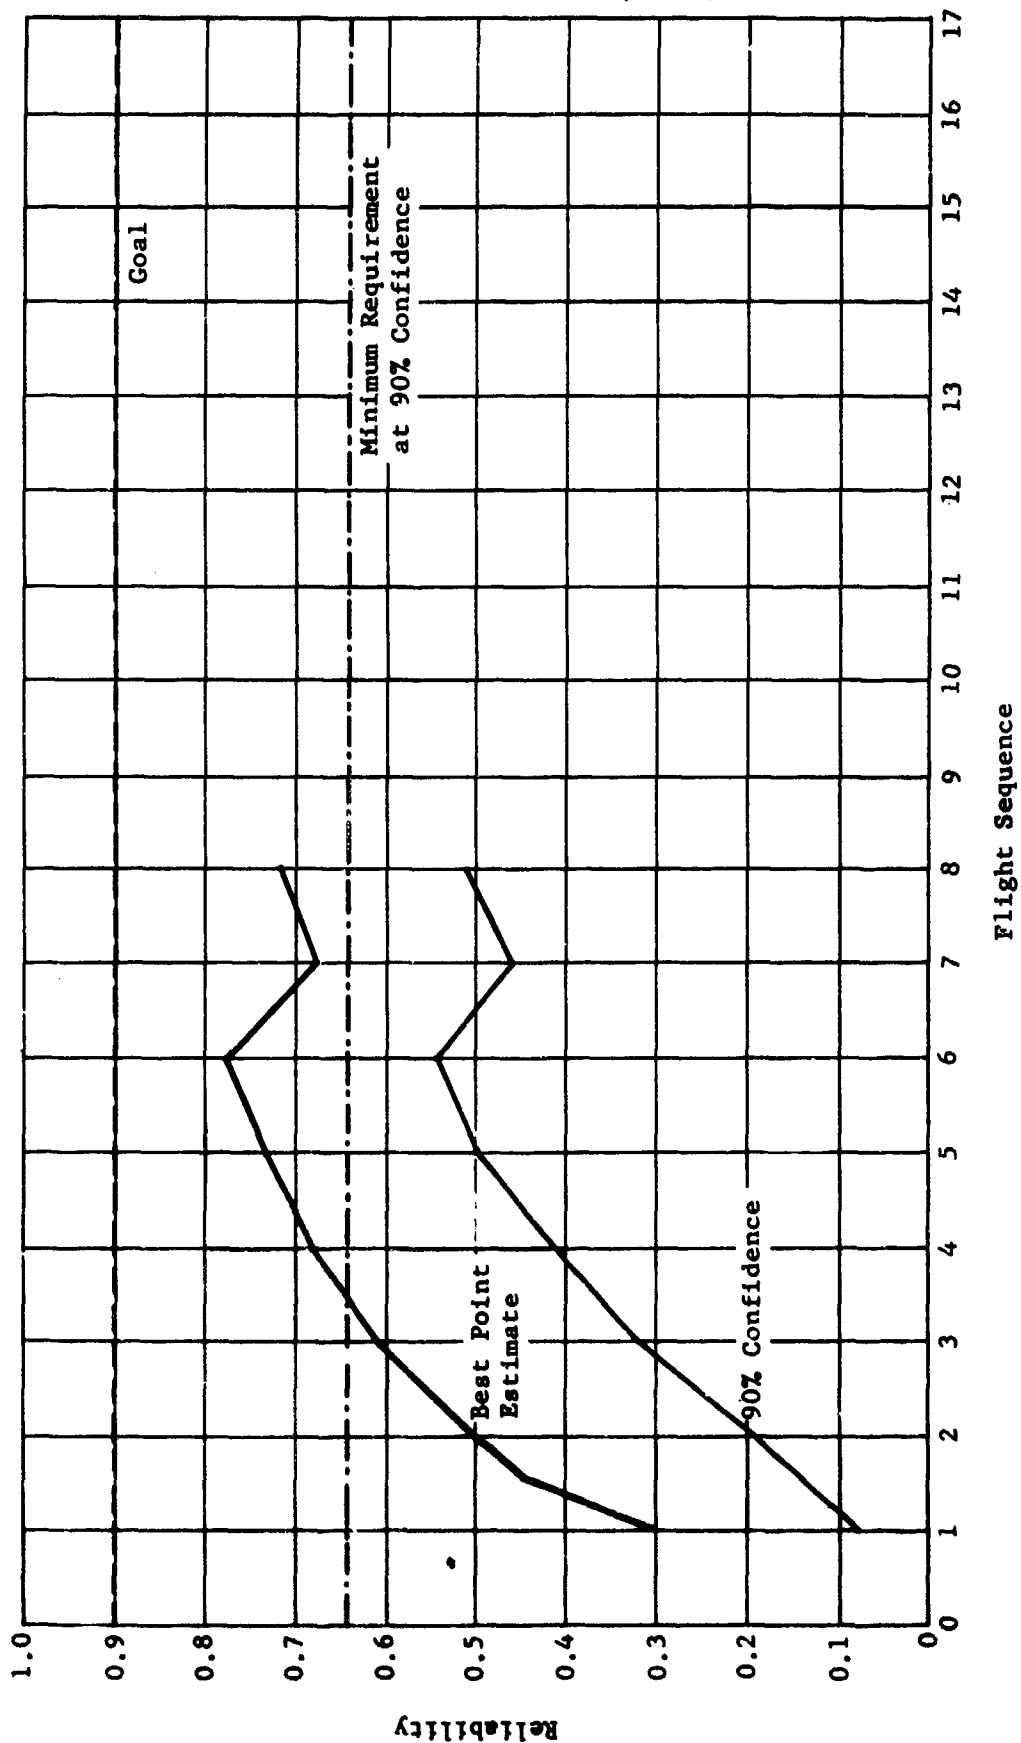
Fig. 3 Reliability Measurement (Mission Objective Criteria) for Martin Portion of Titan III during Flight

In addition to the performance measurements, the Flight Reliability Measurement (Mission Objective) for the Martin Portion of Titan III is included. This evaluation represents the probability of success for the Martin portion of Titan III in performing the flight functions required to place a payload into a desired orbit. This evaluation uses gross success and attempt data from Configurations A and C. This evaluation is presented in Fig. 3.

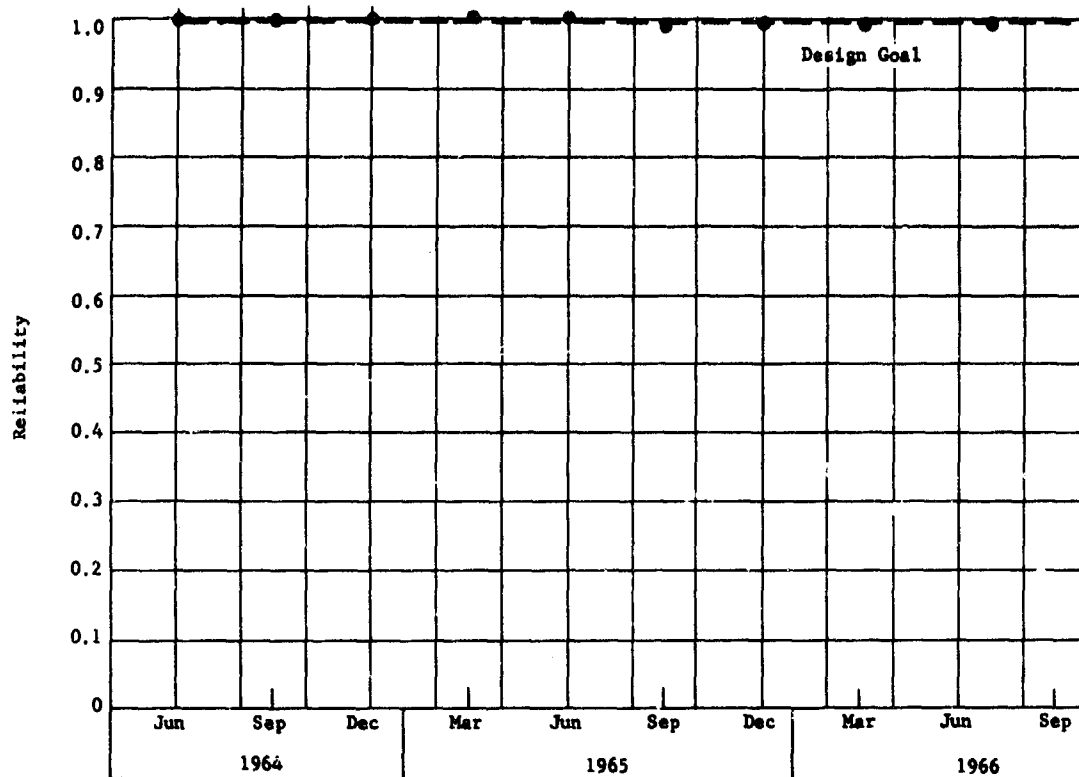
Fig. 4 MDS Design Reliability Estimate, Primary Function

Estimates of achieved and design flight reliability for the malfunction detection system (MDS), primary function vs time, are shown in Fig. 4 and 5. The primary function of the MDS is defined as sensing any impending catastrophic condition and responding with sufficient lead time to abort the spacecraft safely. Techniques used to derive these estimates are included in the appendix. Specific problems causing downward trends are included in Table 4.

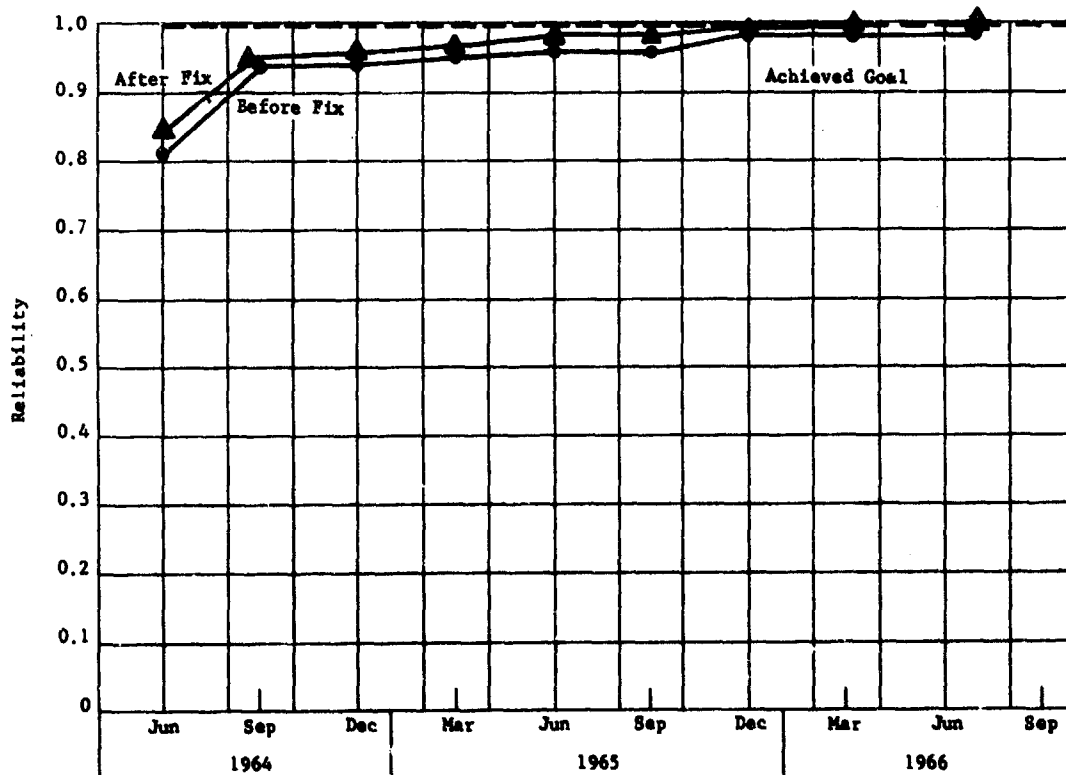
Fig. 5 MDS Achieved Reliability Estimate, Primary Function

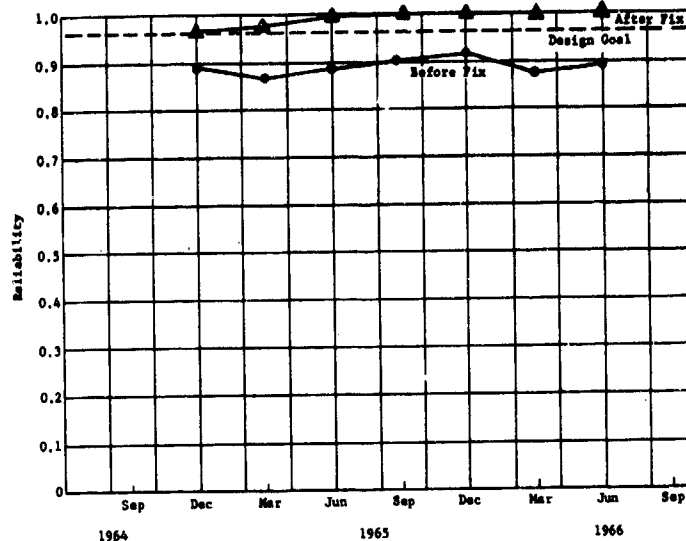
Fig. 6 Design Countdown Reliability Measurement for Martin Portion of Titan III (Configuration C)

Countdown reliability is defined as the probability of conducting the countdown (starting at T - 195 min) through SRM ignition, with no holds occurring that would cause a mission abort. The countdown measurement program for the Martin portion of Titan III is oriented toward measurements of the capability of the hardware, procedure, and personnel required to perform the events/functions in the countdown sequence. Although the countdown measurement program based on these criteria will produce pessimistic estimates, it is a more useful tool in determining weaknesses in three major factors: hardware, procedure, and personnel. To clarify the reference to pessimistic estimates, it is necessary to refer back to the definition and the phrase "with no holds occurring that would cause a mission abort." Many countdown events/functions can fail and be repaired without causing a mission abort, which introduces a fourth major factor, maintainability. The countdown reliability measurement program does not attempt to evaluate maintainability. Therefore, countdown reliability in accordance with the definition is significantly higher than the countdown reliability being measured.

In this quarterly report, measurement of the Martin portion of the Titan III for a Configuration C countdown are included in Figures 6 and 7. Measurements for individual subsystems are included in Tables 5 and 6. Qualitative descriptions of problems and subsequent fixes affecting this measurement are broken down into airborne equipment problems, Table 7, and aerospace ground equipment problems, Table 8.

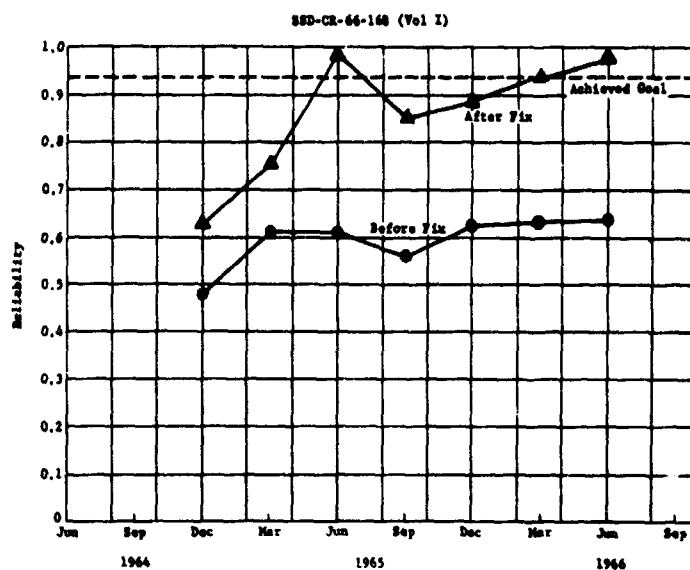
Fig. 7 Achieved Countdown Reliability Measurement for Martin Portion of Titan III (Configuration C)

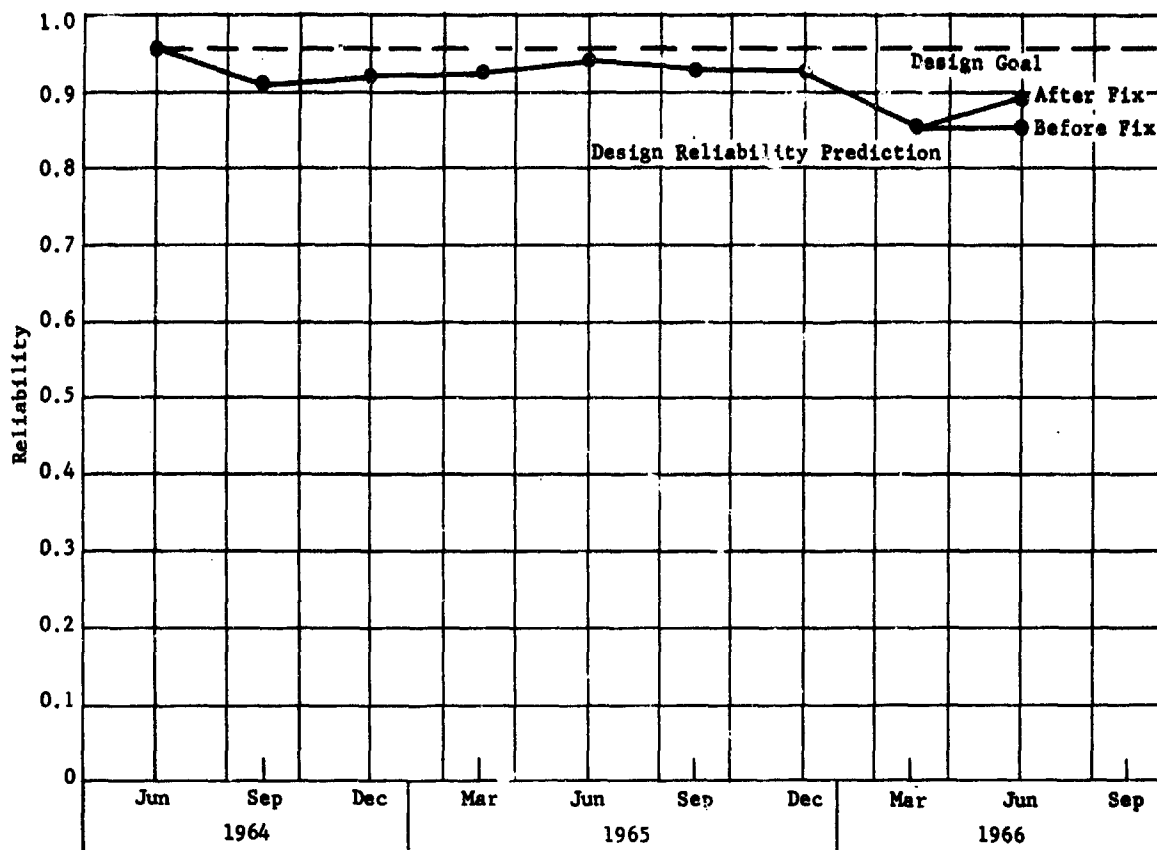
Fig. 8 Design Reliability Prediction for Martin Portion of Titan III (Configuration A) during Flight

- 1) Design Reliability Prediction for Martin Portion of Titan III (Configuration A) during Flight, Fig. 8;
- 2) Achieved Reliability Prediction for Martin Portion of Titan III (Configuration A) during Flight, Fig. 9;
- 3) Design Reliability Prediction for Martin Portion of Titan III (Configuration C) during Flight, Fig. 10;
- 4) Achieved Reliability Prediction for Martin Portion of Titan III (Configuration C) during Flight, Fig. 11.

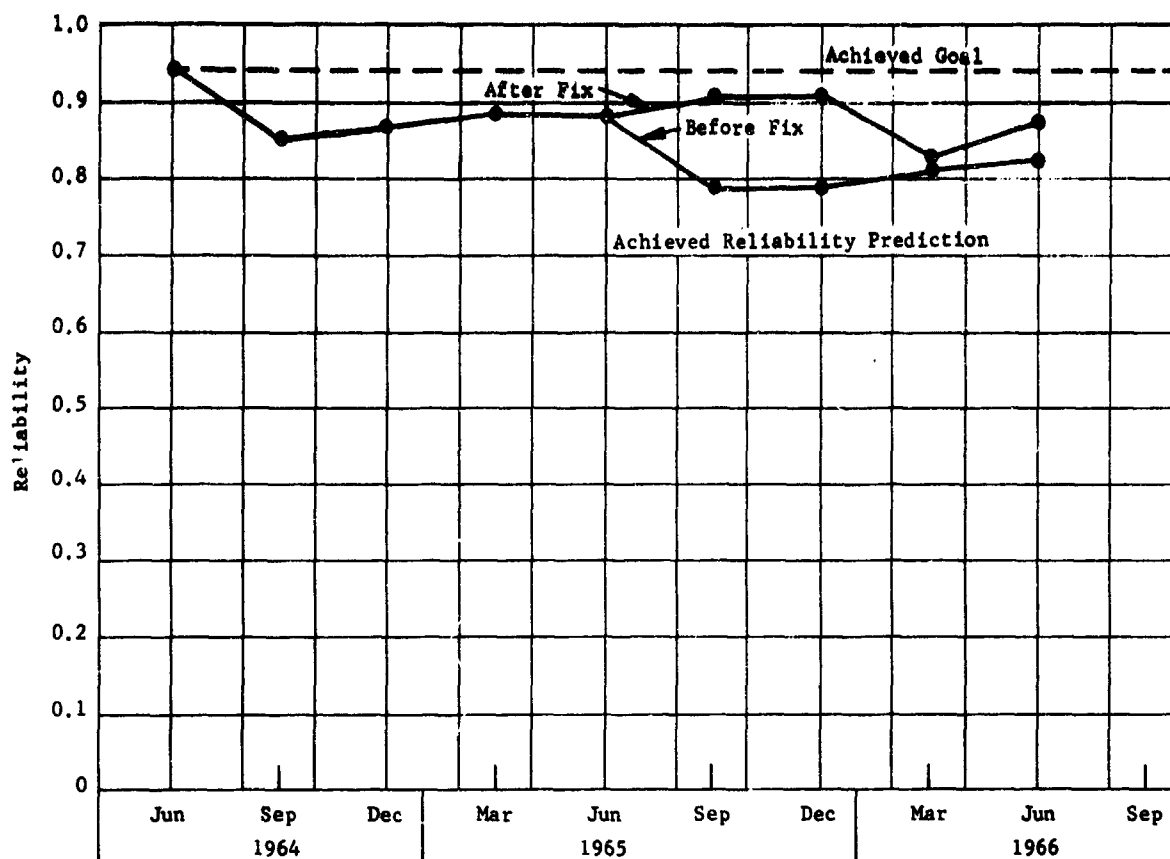
Fig. 9 Achieved Reliability Prediction for Martin Portion of Titan III (Configuration A) during Flight

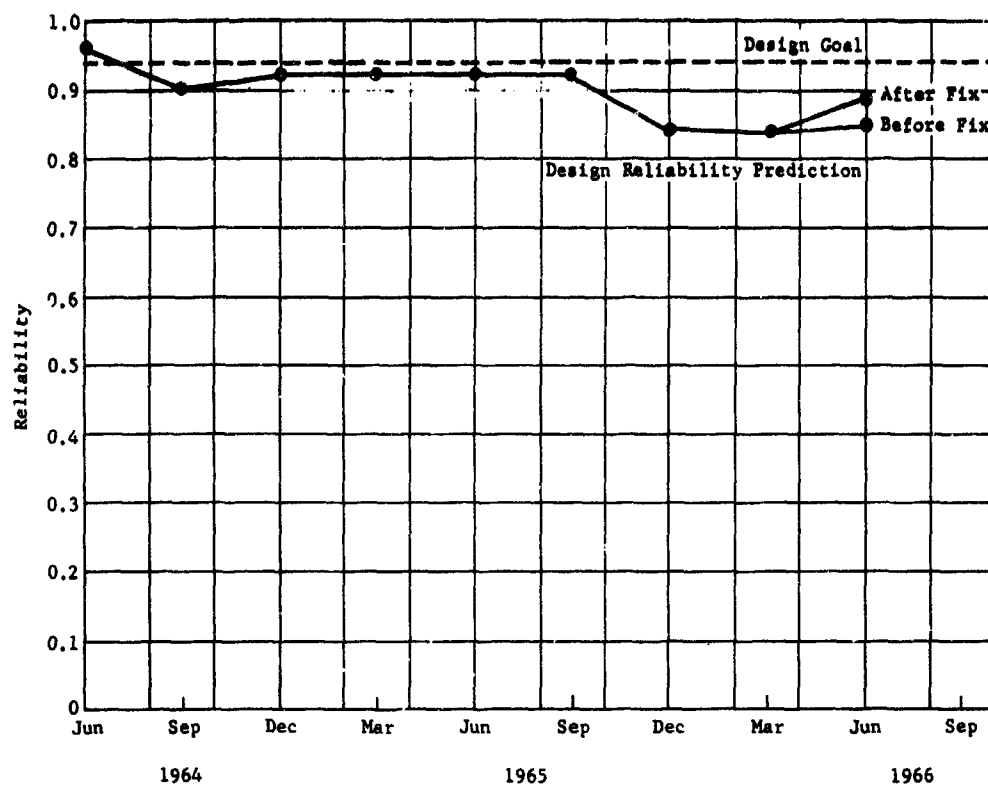
Fig. 10 Design Reliability Prediction for Martin Portion of Titan III (Configuration C) during Flight

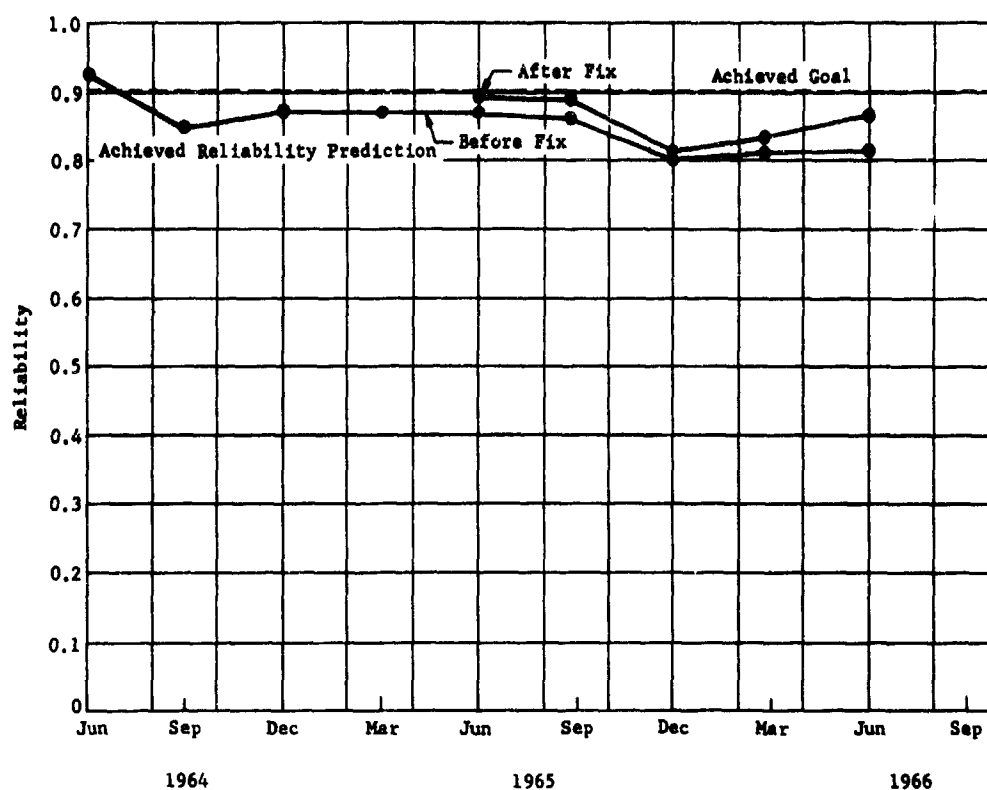
Fig. 11 Achieved Reliability Prediction for Martin Portion of Titan III (Configuration C) during Flight
